September 30, 2022
Nippon Steel Corporation

Submission of the Report on the Effluent Incidents at Kimitsu Area of East Nippon Works

Content of the Report Submitted to Chiba Prefecture and Kisarazu, Kimitsu, Futtsu Cities

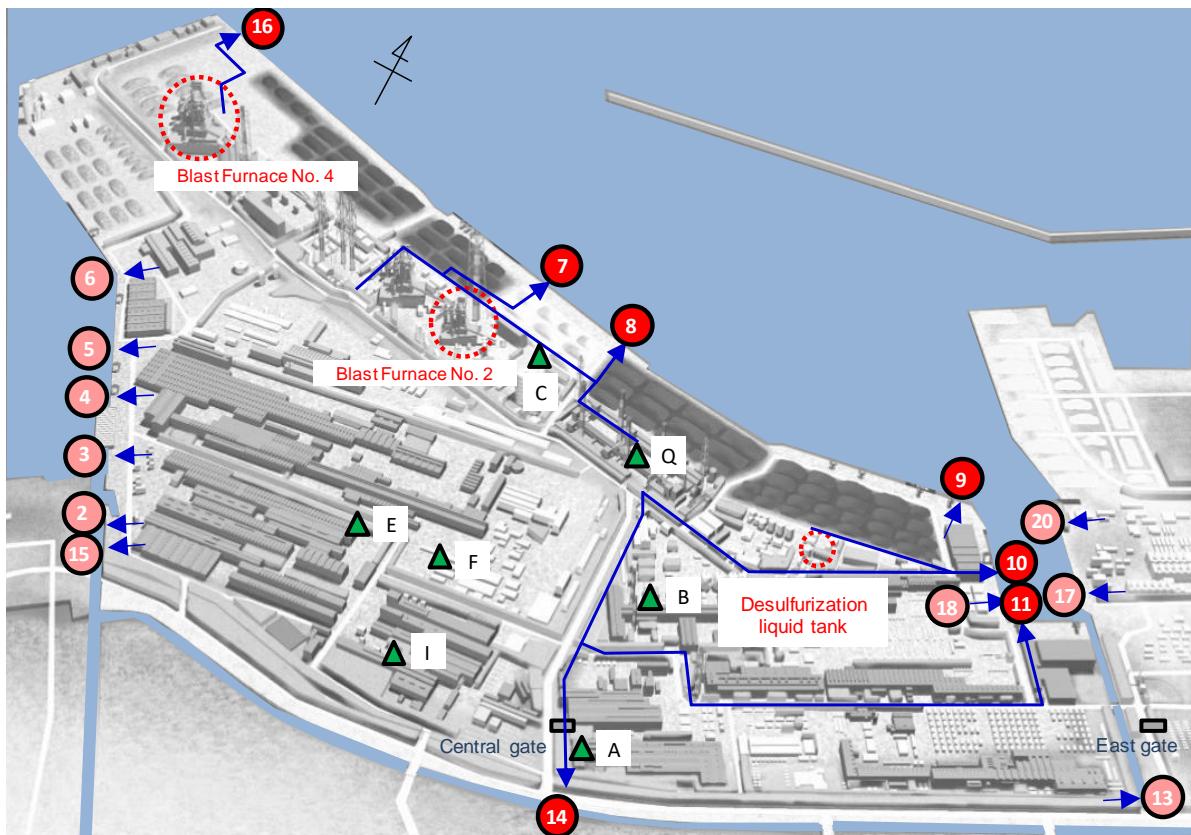
<Figure:1> Outline of effluent outlets and drainage channels at Kimitsu Area of East Nippon Works

- Outlets at 17 points (Nos. 1, 12, and 19 have been closed.)
→ The Water Pollution Prevention Act applies to these outlets. (Effluent standards)
- △ Drainage channels at 7 points
→ Subject to the Agreement Concerning Environmental Preservation among the Prefecture and Three Cities (Agreement values)

Symbol	Drainage channel name	Outlet
A	Small diameter pipe return water drainage channel	⑪
B	Bar steel return water drainage channel	⑩
C	Dust collection secondary treatment drainage channel	⑧
E	Cold rolling-1 weak acid treatment drainage channel	⑯
F	Oil-containing wastewater treatment drainage channel	⑯
I	EGL process drainage channel	⑯
Q	Ammoniacal liquor secondary treatment drainage channel	⑧

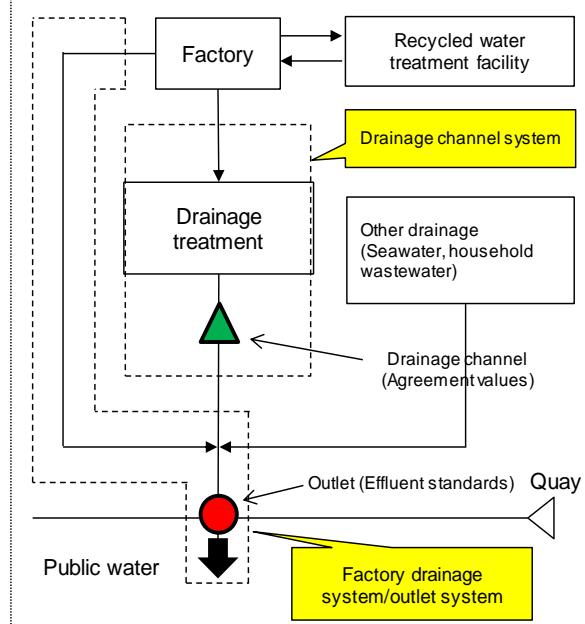
Locations which Effluent standards/Agreement values apply to drainage system (concept)
